# POINT PLEASANT BRIDGE COLLAPSE

ON DECEMBER 15, 1967, THE BRIDGE CONNECTING POINT PLEASANT, WEST VIRGINIA, AND KANAUGA, OHIO, COLLAPSED INTO THE OHIO RIVER, carrying 46 persons to their deaths. NBS experts played a prominent role in the laboratory examinations of steel members from the failed structure, providing key findings as to the underlying cause of the disaster. In brief, NBS found that corrosion in the head end of an eyebar led to the development of stress corrosion cracks; over a period of years one of these reached a depth of about 1/8 inch. At this point the metal, of a type having low resistance to fracture once a "notch" had been established, failed catastrophically, causing the bridge to collapse. NBS work in this investigation was done at the request of and with the financial support of the Bureau of Public Roads, Department of Transportation.

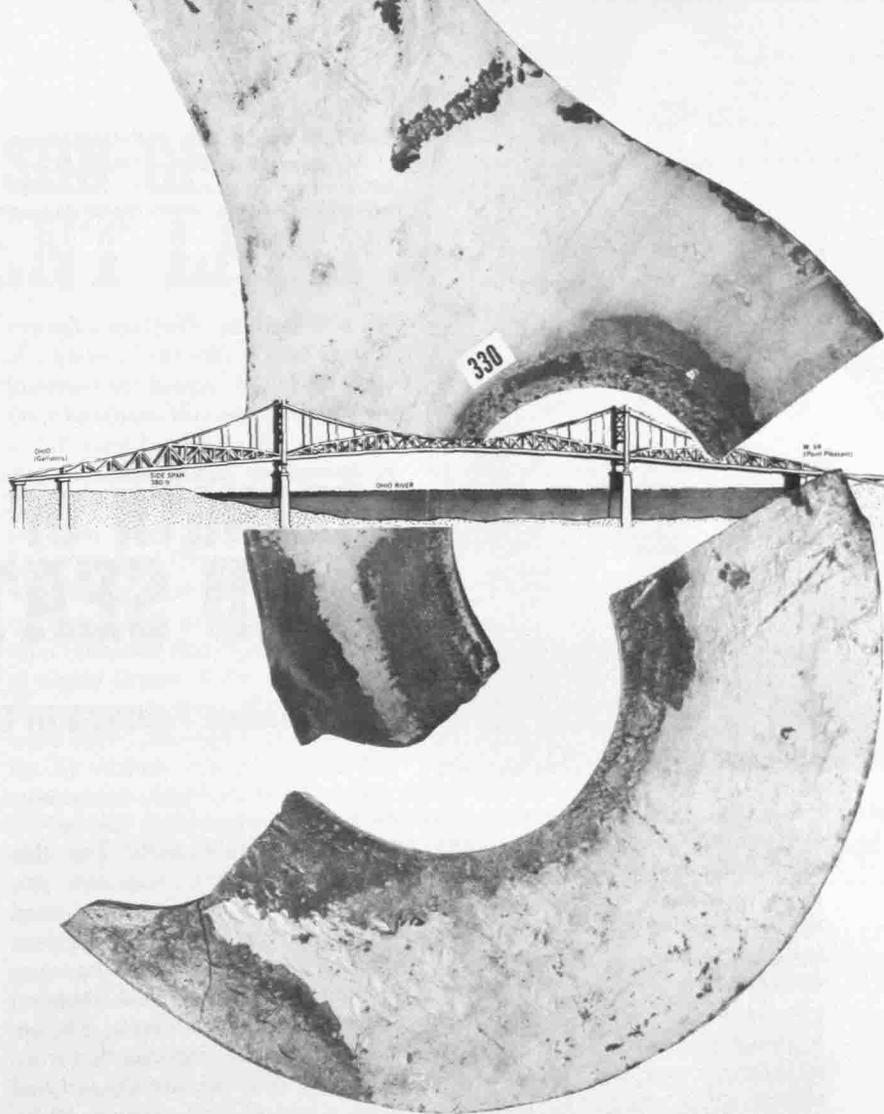
posite sides of the broken eye are quite different. On one side the fracture is a straight line, the surface exposed by the break is quite brittle in appearance, and there is little evidence of plastic deformation adjacent to the break. The other fracture does not follow a straight line, has a very rough exposed surface, and shows extensive plastic deformation in the adjacent areas. The different appearance of the two fractures results from their nature and the sequence of events. The straight line fracture, an almost instantaneous event once the notch reached the critical depth of about 1/8 inch, occurred first. The failure then shifted an unsupportable load to the other side of the eye, which deformed extensively before breakage occurred. Careful cleaning of the specimens, followed by microscopic examination of various surfaces, revealed cracks penetrating into the metal from the hole surface, particularly in the area near the existing straight-line fracture, and in an area where there was heavy corrosion. The cracks not involved in failure were oxide-filled, indicating they had been open for some time.

Close-up view of the eyebar responsible for the Point Pleasant Bridge collapse, and an artist's drawing of the bridge. The straight line fracture, an almost instantaneous event once a notch, caused by stress corrosion, reached a critical depth of about 1/8 inch, occurred first. The failure then shifted an unsupportable load to the other side of the eye, which deformed extensively before breakage occurred.

The lower side of the eye (straight fracture) fractured under loads that were not sufficient to cause appreciable plastic deformation of the steel.

The faces of both the pre-existing crack associated with the main fracture and similar cracks in adjacent areas were covered with dark oxides of a distinctly different color and texture than surface rusting that developed on the remainder of the fracture surface. Microprobe

analyses revealed the presence of more than normal amounts of sulfur in the crack surface. This indicated that sulfur bearing gases such as sulfur dioxide or hydrogen-sulfide in the atmosphere (air pollutants) may have been responsible for the stress-corrosion cracking.

As a result of the complete investigation, the President-appointed Task Force on Bridge Safety concluded<sup>1</sup> that a small crack, which started at a small corrosion pit and grew to critical size by the joint action of stress-corrosion cracking and corrosion fatigue, was responsible for the bridge collapse.
